**Major U.S. Cities Using National Standard Fire
Hydrants, One Century After the Great Baltimore
Fire**

August 2004

Fire Research Division
Building and Fire Research Laboratory
National Institute of Standards and Technology
Gaithersburg, MD 20899

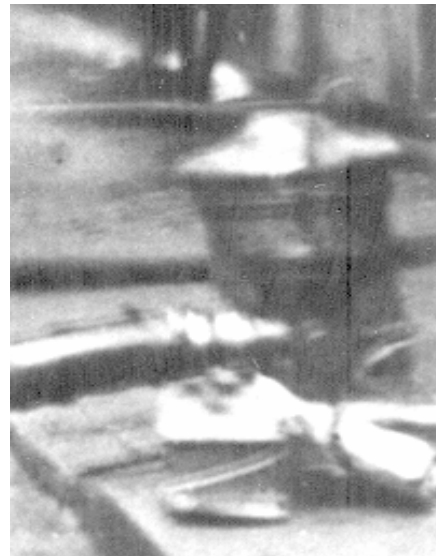
Fig. 1: (a) Picture of one fire engine battling the fire during the Great Baltimore fire. (b) Close-up of the lower right corner of picture 1a showing a 1904 Baltimore hydrant. The tallest object in the background is the cover of the hydrant that is right in front of it. The cover is removed to expose the hose connection of the fire hydrant. (Courtesy of the Baltimore Sun)[4]

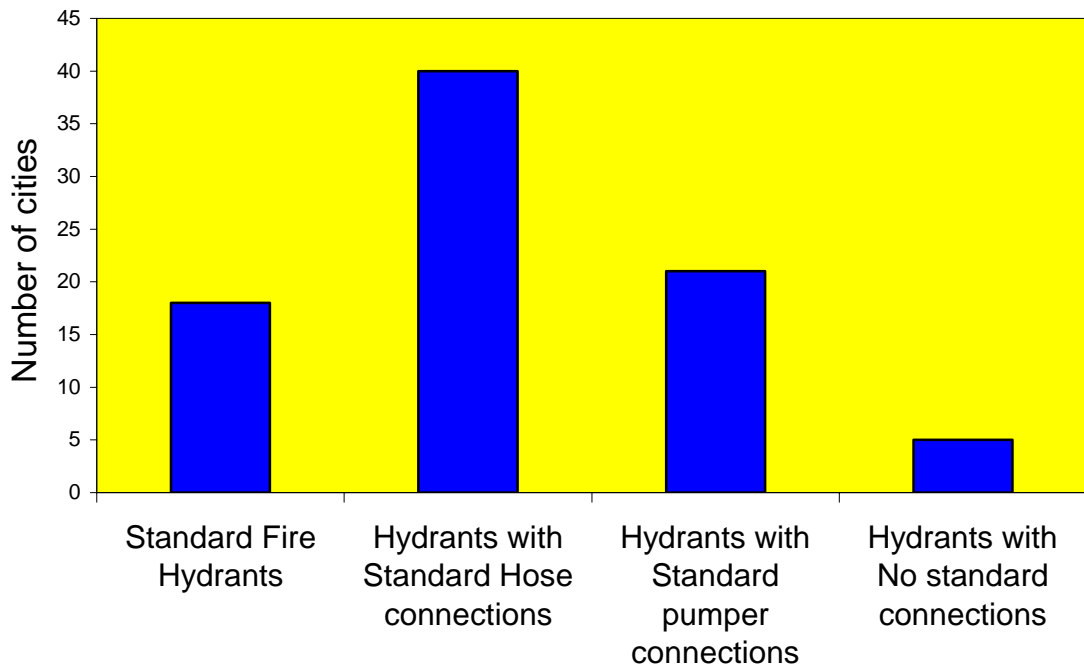
Using the data in Table 1, Figure 3 below shows an overview of the extent to which the largest 48 cities in the U.S. have adopted the national standard specifications for fire hydrants.

Figure 3: The number of cities with the different kinds of connections.
